**Block 143, Lot 24.06
Area in Need of Redevelopment Investigation Report**

**Township of North Brunswick
Middlesex County, New Jersey**

June 13, 2024

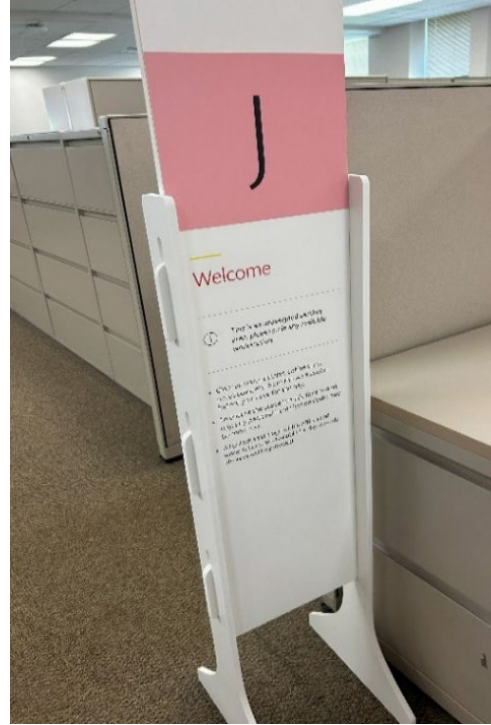
Figure 6 (Left) – Open workspaces for technology professionals.
Figure 7 (Right) – Signage within an open workspace, noting of the unassigned seating arrangement.

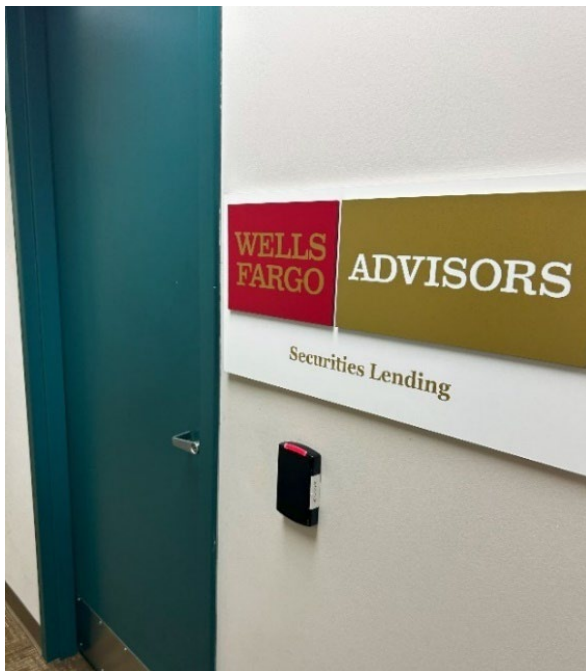
Figure 8 (Left) – Secure room for current Wells Fargo employees.
Figure 9 (Right) – Signage reflecting former banking, management, and computing tenants.

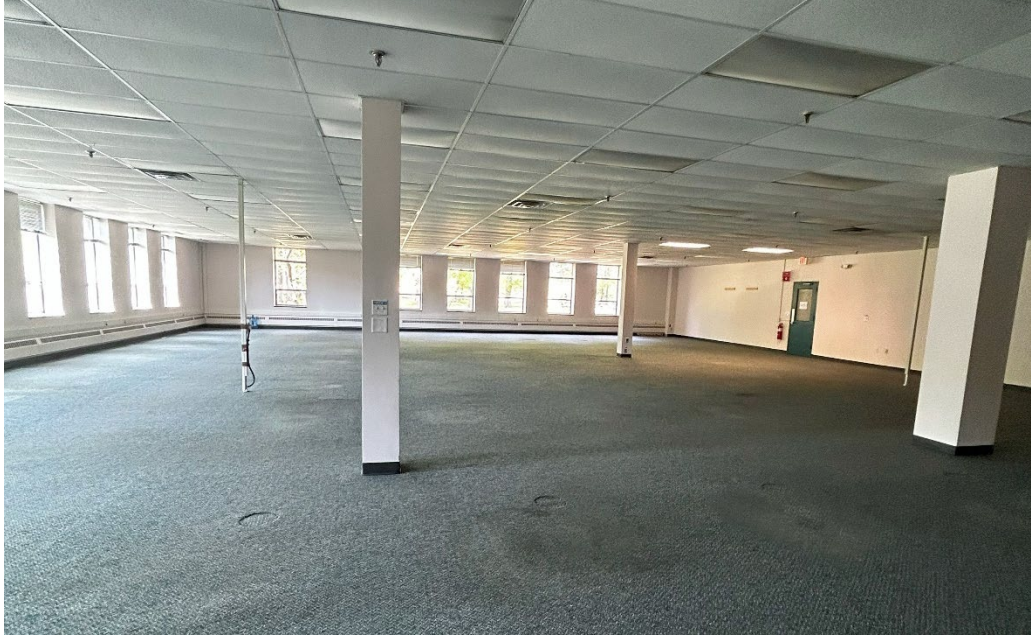
The main building/Building 100 is the most occupied building within the complex and hosts the remaining corporate employees of Wells Fargo. This building also offers open computer workspaces that provide redundancy in the event of power or communication system disruptions as an alternate workspace for employees based elsewhere. Conversations with the property manager revealed that around 300 workers utilize the open workspaces each day during the week (Figures 6 and 7). The building also includes conference rooms and secure meeting rooms utilized by Wells Fargo (Figure 8). Signage of past tenants can still be found within the main building (Figure 9). While this building is the most occupied throughout the complex, it contains vacant office spaces (Figure 10).

Figure 10 – Vacant office space within Building 100.

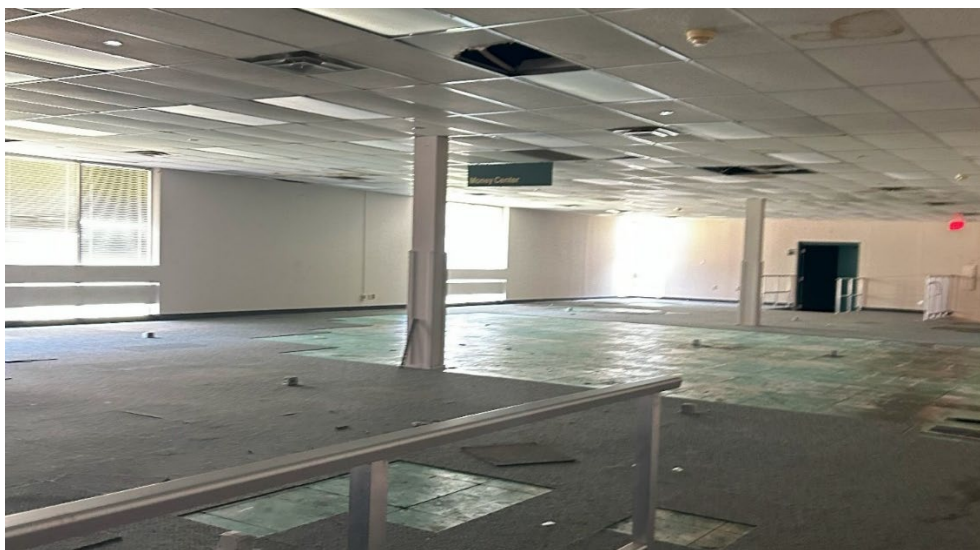
The first addition to the main office complex was constructed in the 1960s. This space has accommodated various uses over the years, and most recently accommodated the Wells Fargo Money Center (Figure 11). Extensive disrepair is evident throughout this building. Ceiling and floor tiles are rotting and missing, and ductwork is exposed due to corrosion and water damage (Figure 12). Flood electrical outlets stick out of the floors, spanning across a space that has evidently been unoccupied for years. Long-term vacancies are further alluded within the space's deteriorating furnishings and finishes (Figure 13).

Figure 11 – Overview of the former Money Center, now entirely vacant and deteriorated.

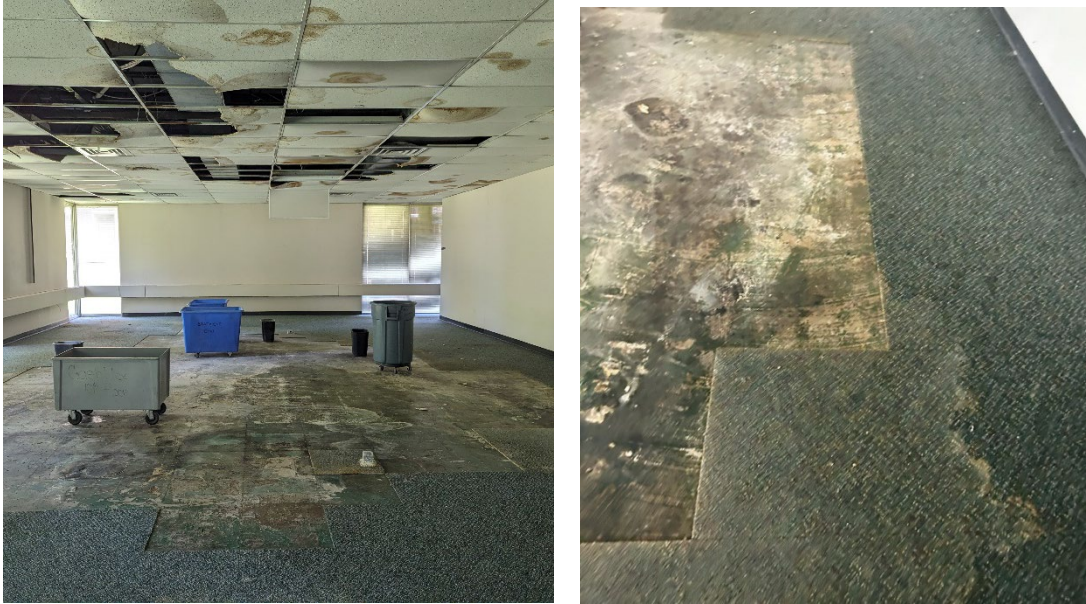
*Figure 12 (Left)– Extensive corrosion within floor and ceiling tiles.
Figure 13 (Right) – A deteriorating rug, lined with mold.*

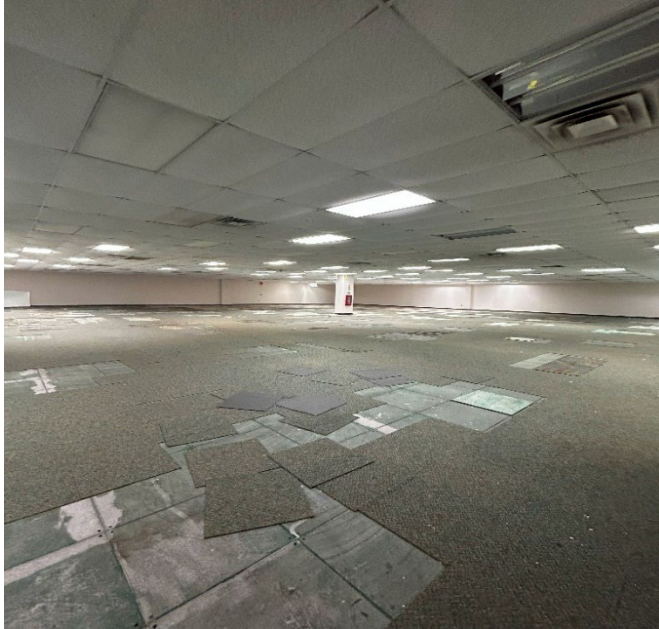
The former Data Center was constructed as a second addition to the main complex in the 1980s. Equipped with high-tech machinery, this space was designed with raised floors and an open floor plan (Figure 14). This space presents some of the complex's worst disrepair; several floor tiles have been removed or damaged, water damage is extensive, and loose wiring is exposed (Figure 15). Piles of wood, scrap material, and trash have been scattered across the space. Pieces of machinery have been abandoned, reiterating the long-term abandonment of the Data Center (Figures 16 and 17). This building is evidently unwholesome and untenable (Figure 18).

Figure 14 (Left) – Open concept floor plan of the old Data Center.
Figure 15 (Right) – Damaged ceiling and floor tiles and loose wiring within Building 230.

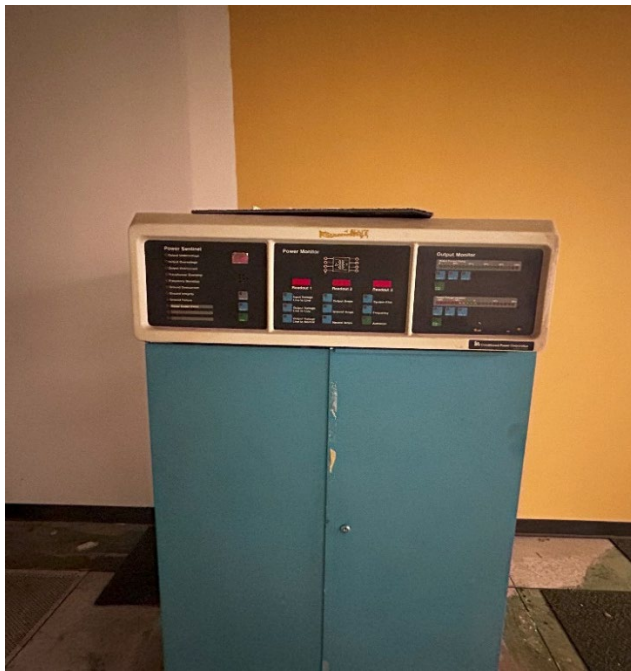
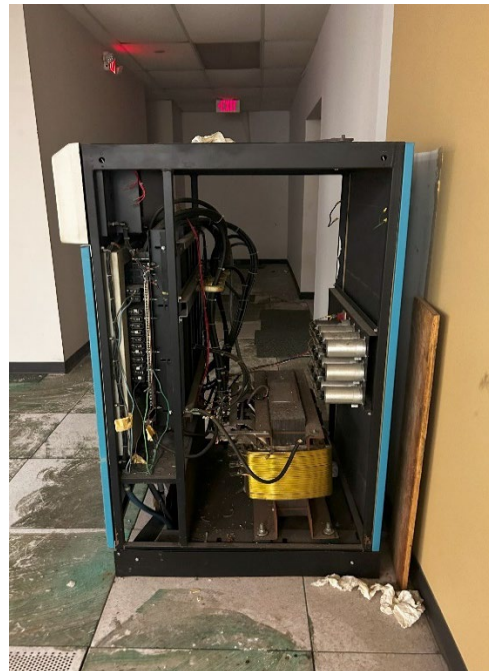
Figures 16 and 17 – Remnants of old computing machinery left behind.

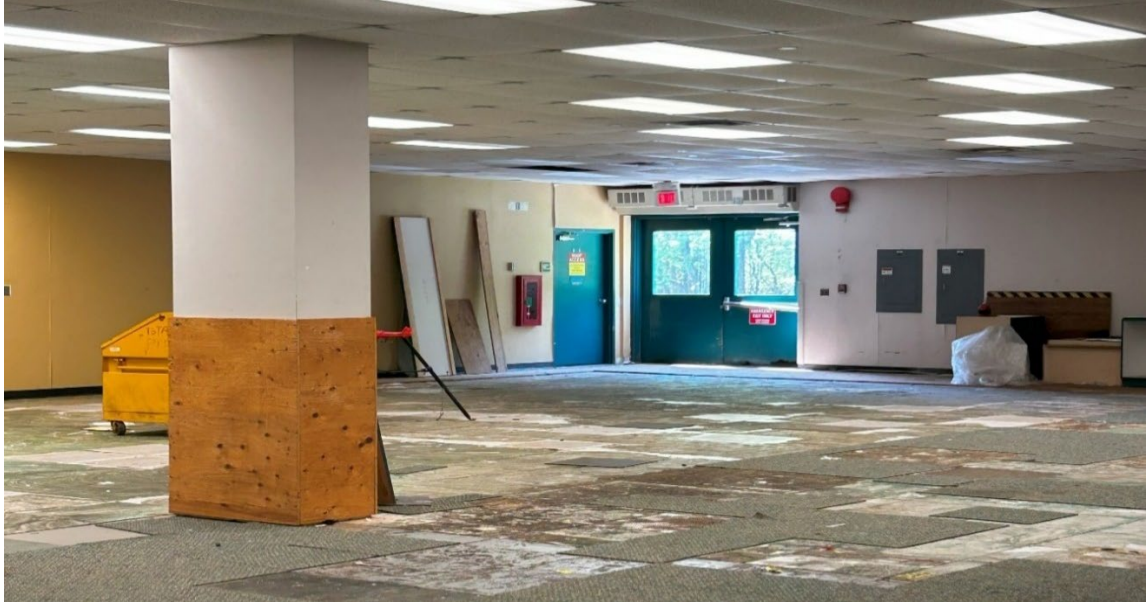
Figure 18 – Damaged floor tiles and wrapped column within the old Data Center.

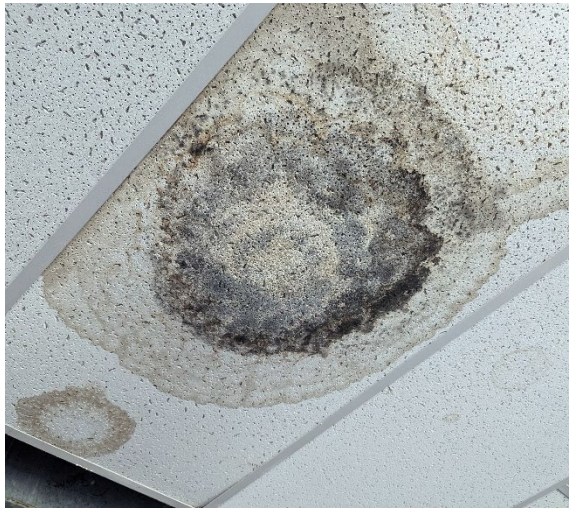
The remaining buildings within the southern section of the complex demonstrate a similar degree of vacancy and deterioration to the old Data and Money Centers. These wide-open spaces present tiles and columns affected by water damage (Figure 19). Inactive light fixtures with exposed wiring remain in the building (Figure 20), and mechanical equipment has haphazardly been exposed within the entrance hallway (Figure 21).

*Figure 19 (Left)– Evidence of water damage within the ceiling tiles in Building 180.
Figure 20 (Right) – Inactive light fixtures left abandoned.*

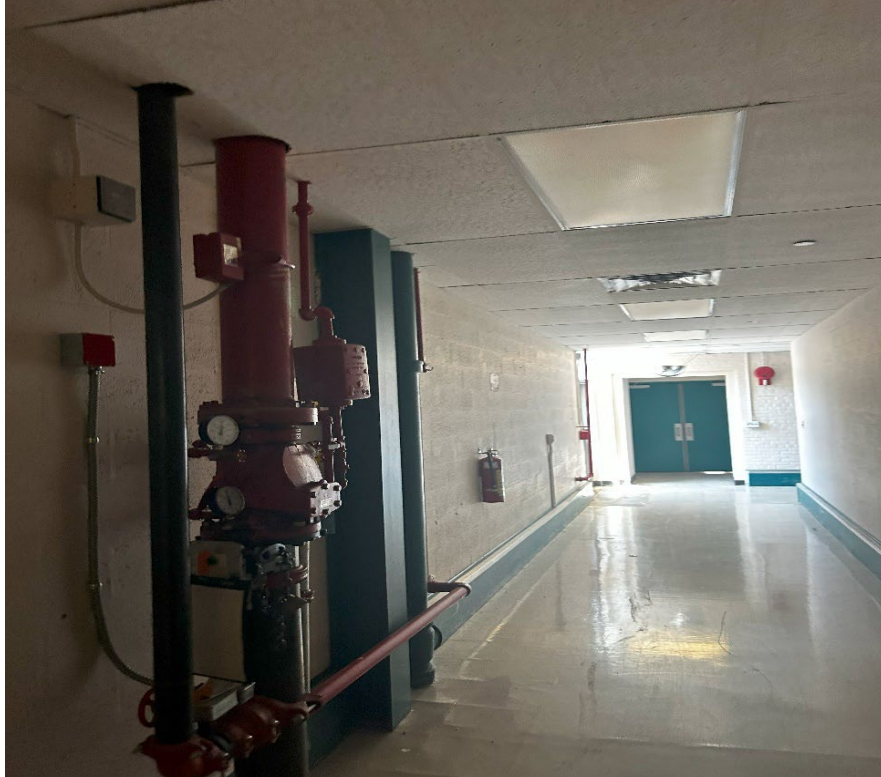
Figure 21 – Exposed piping and meters within the hallway of Building 180.

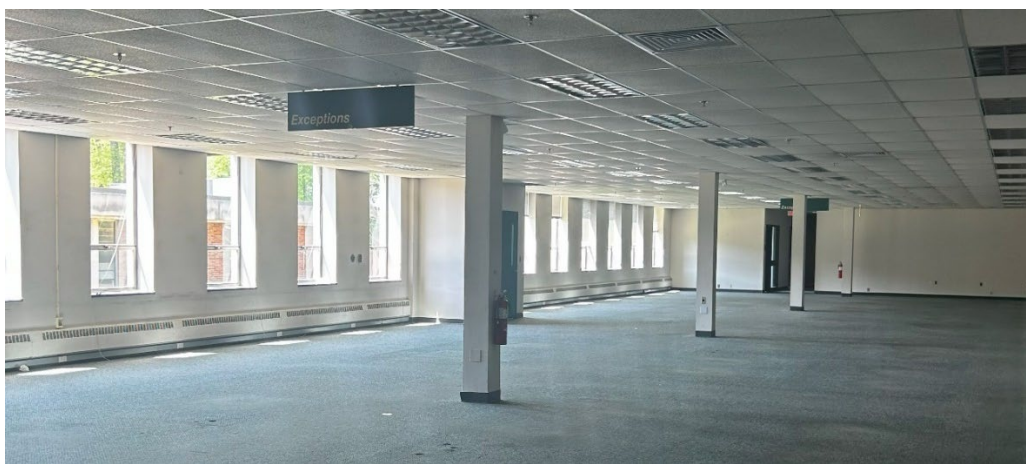
Buildings 150 and 175 demonstrate similar conditions to the other office spaces throughout the complex (Figure 22). These spaces include old air conditioning units hanging from the ceiling (Figure 23) and several instances of exposed wiring (Figure 24). Water damage is apparent within the ceiling tiles and floorboards. A deteriorating column was observed in an old computing room (Figure 25). Further evidence of disuse of the spaces is apparent in the vintage timecard machines (Figure 26).

Figure 22 – Vacant office space, formerly an Exceptions Department for Wells Fargo.

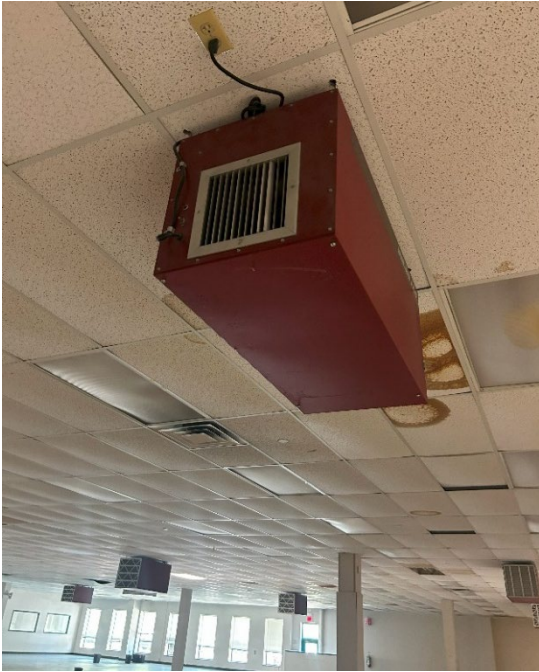
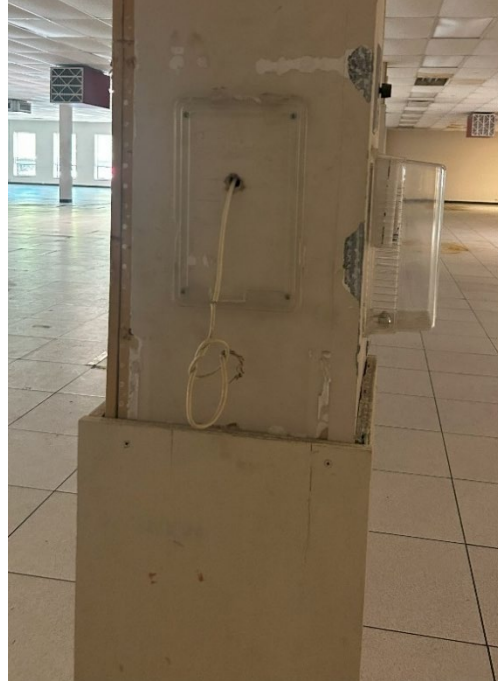
Figure 23 (Left) – Remains of an old air conditioning unit, plugged haphazardly into the ceiling.
Figure 24 (Right) – Exposed wiring from an old thermometer.

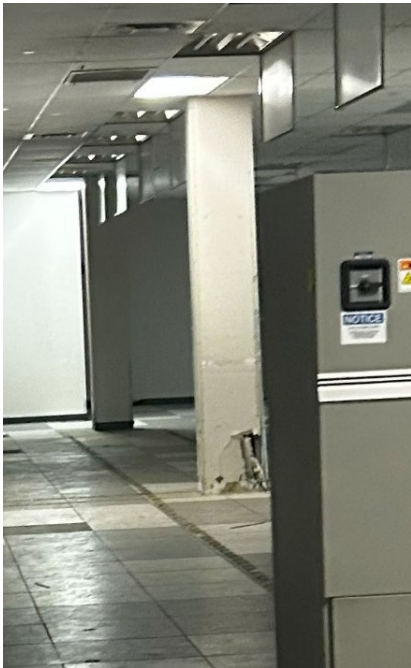
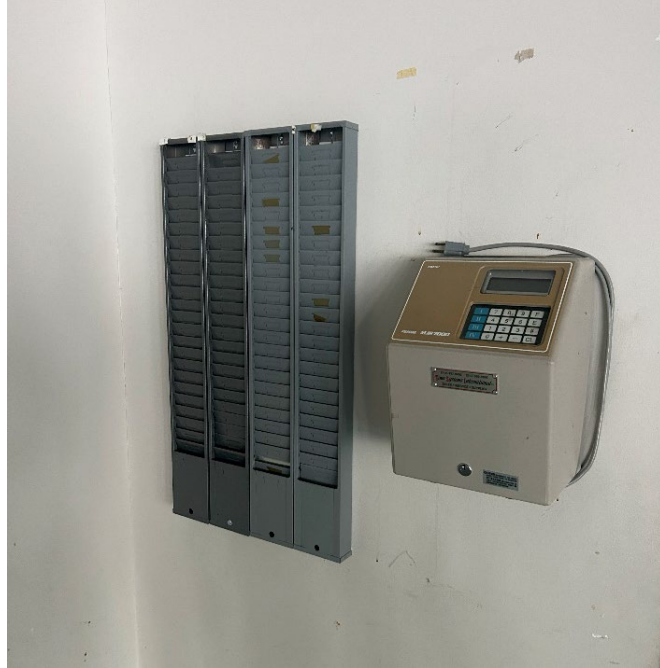
Figure 25 (Left) – Damaged column within an old computing room.
Figure 26 (Right) – Vintage timecard machine within an abandoned office space.

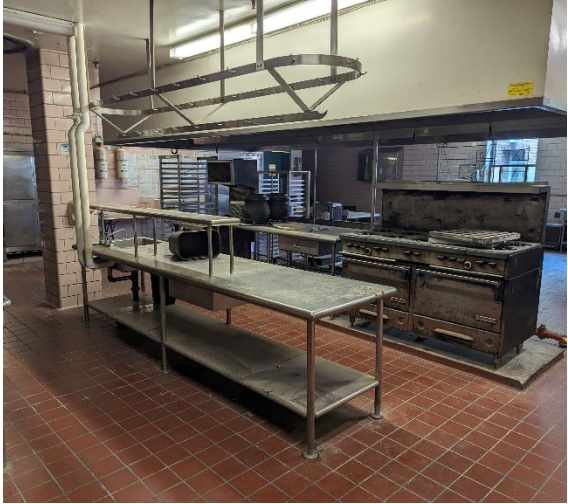
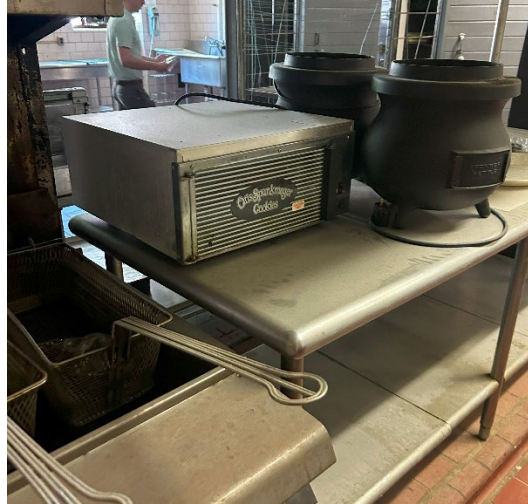
At its peak occupancy, the complex contained a fully operating kitchen to serve its employees (Figure 27). The kitchen has not operated for years, following the complex's reduction of on-site employees. This lack

*Figure 27 (Left) – Former food preparation area to service the complex's employees.
Figure 28 (Right) – Abandoned appliances within the kitchen.*

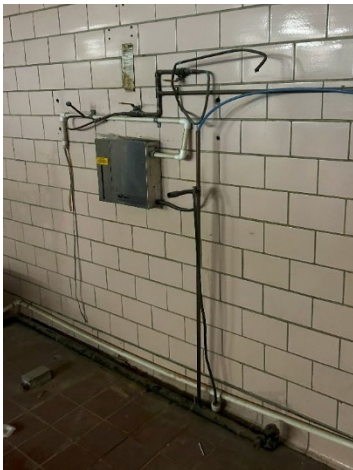
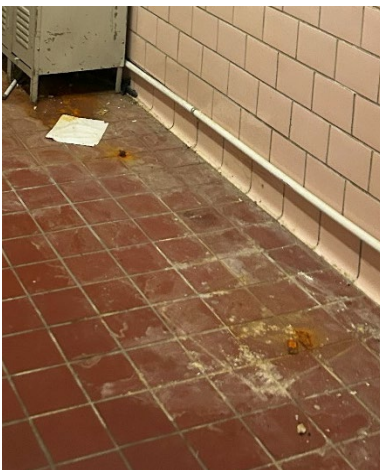
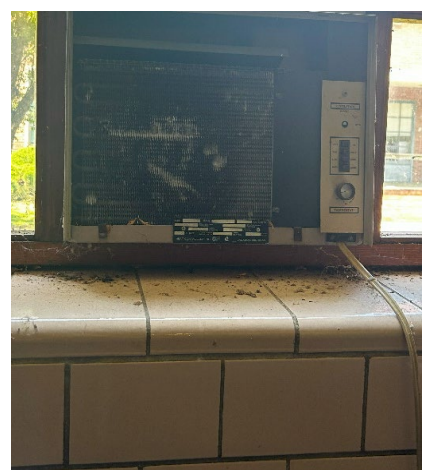
of occupancy is evident in the space's inactive appliances and abandoned furniture (Figure 28). Rust and mold have begun to accumulate around old wires and outlets (Figure 29), and animal droppings were observed throughout the kitchen area (Figures 30 and 31). These spaces present unsanitary and unwholesome conditions.

*Figure 29 (Left) – Rusted and exposed wiring within the kitchen.
Figure 30 (Middle)– Evidence of animal droppings within on the kitchen floor.
Figure 31 (Right) – Evidence of animal droppings on a windowsill in a kitchen storage room.*

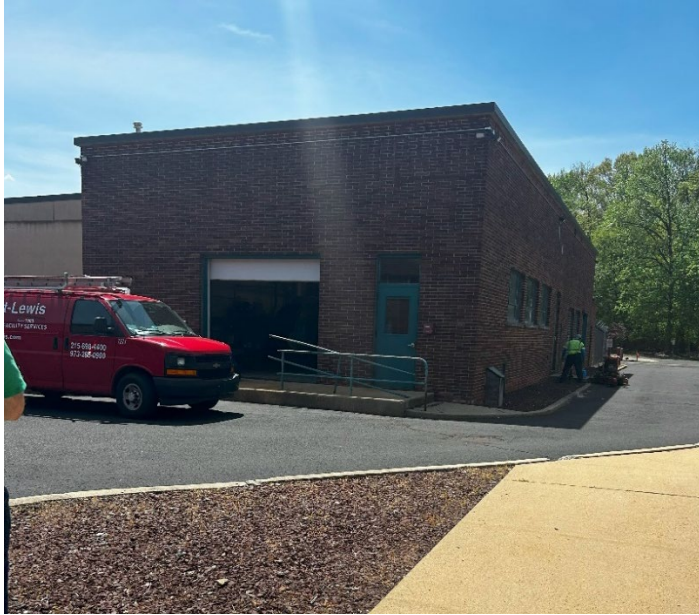
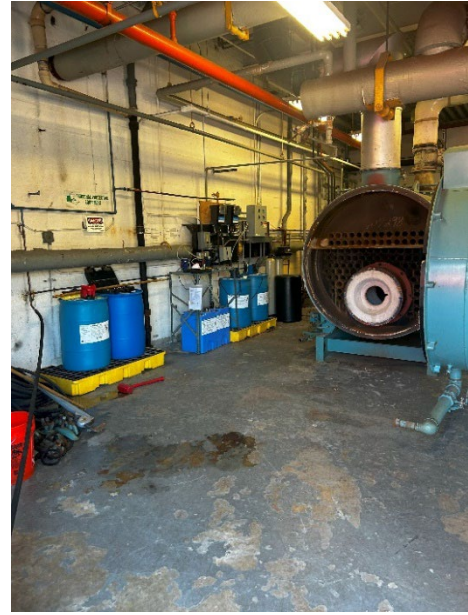
The complex is serviced by an exterior utility/boiler room (Figures 32 and 33), and a network of generators (Figures 34 and 35). The utility building was constructed at the time of the original office building, and is accessed by a driveway from the Fidelity Plaza roadway. Several parking areas within this section of the Study Area remained empty (Figure 36), even in the middle of the workday. The exterior grounds are seen in Figures 37 and 38.

Figure 32 (Left) and Figure 33 (Right) – Separate Boiler room to service the complex of buildings.

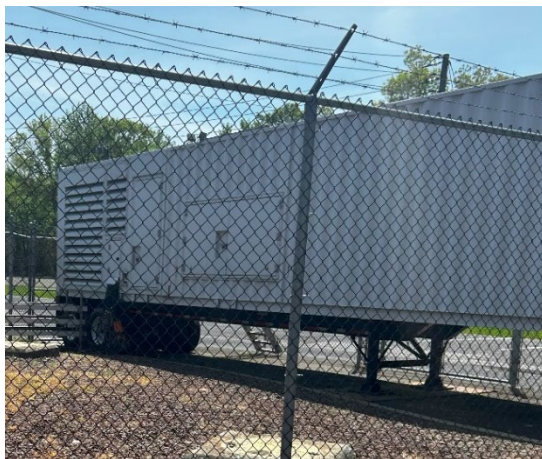
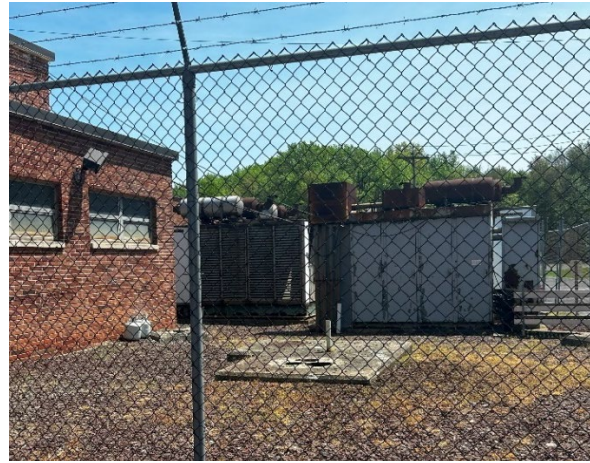
*Figure 34 (Left) – New generator to service the complex.
Figure 35 (Right) – Old generators which serviced the complex.*
